Safety Inspection Report

Annual Inspection

Saxon Green

Great Paxton Parish Council

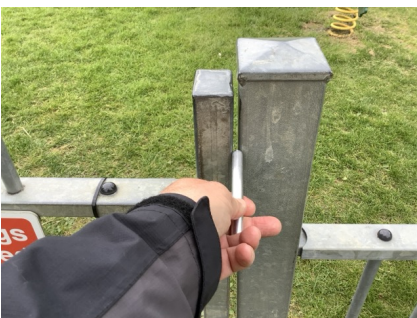
There is a crushing or shearing point on the side of the gate. Where the gaps reduce to less than 12 mm these have been known to cause serious, permanent injury to children, especially on the hinge side where the leverage forces are significant.

Adjust gate / posts / fit new rubber buffer to ensure a spacing of at least 12 mm throughout the range of the gate to remove the entrapment. The 12 mm gap also should apply on the hinge side of the gate.

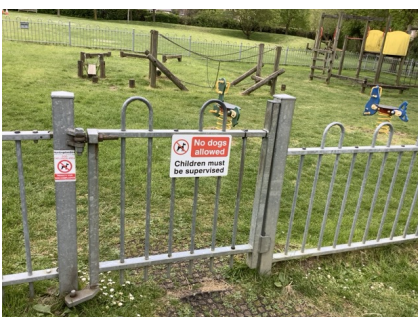
Dog ban & ownership signs recommended.

Operator signs should be installed at each entrance with the correct information on them. Operator's name and contact number etc. please see link attached. www.rospa.com/Play-Safety/Advice/Signs.aspx

See <https://www.rospa.com/en/Play-Safety/Advice/Signs>

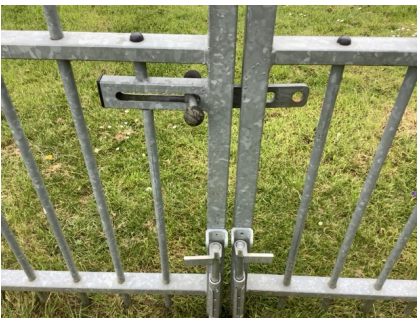
The item is unlocked.

Lock.

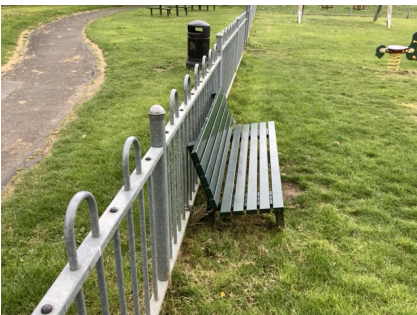
RoSPA recommend a minimum distance of 1 m between seat and fence. This is to reduce the likelihood of children vaulting the fence via the seat.

People can climb onto the seating and jump over the fencing.

No reasonably practicable action is identified.

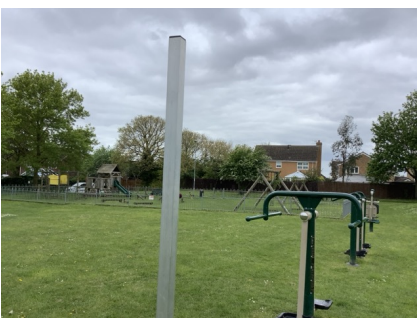
Item has some parts missing.

Sign missing.

Replace the missing parts.

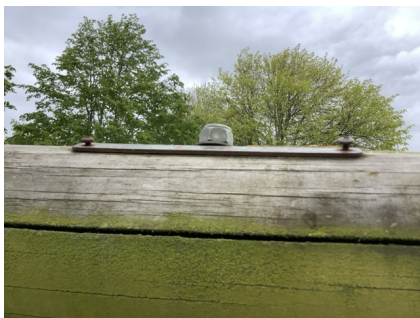
Fixtures loose or missing.

Top bar swing hanger plate screws loose.

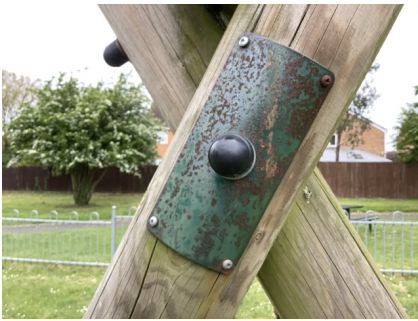
Paintwork is in poor condition.

De-scale back to good base material and coat with lead free paint, using appropriate precautions. Repairs may be necessary where corrosion is severe.

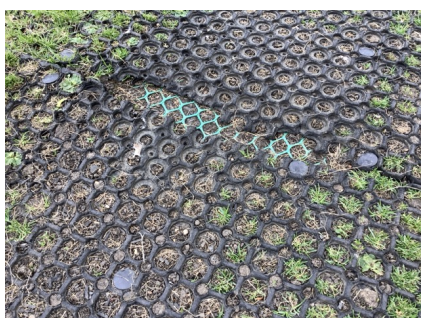
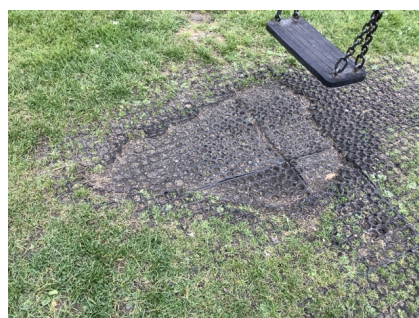
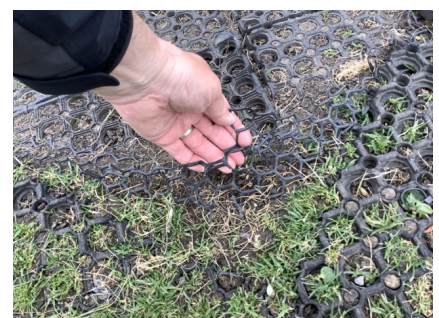
Surface needs repair.

Surface damaged. Replace.

Replace.

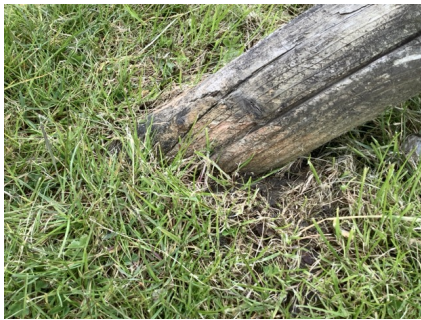
Strimmer damage is present on posts, allowing water to enter and timbers to soften. It can also remove the protective envelope around the timber. Prevent further damage and check timbers for decay throughout the year.

Strimmer damage to the base of the uprights. This will allow water in and shorten the life span of the unit. Re-seal the damaged area and adjust the grass cutting program.

Prevent further damage.

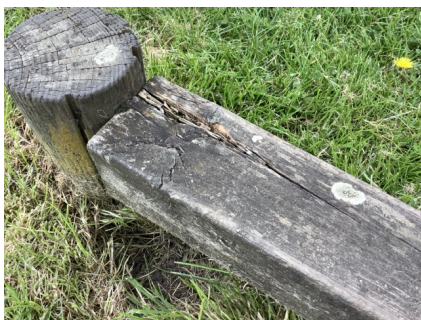
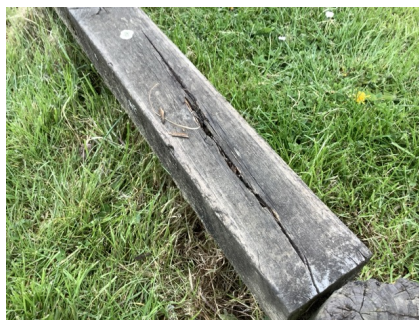
Timber is decayed.

Balance beam decaying.

Replace affected parts.

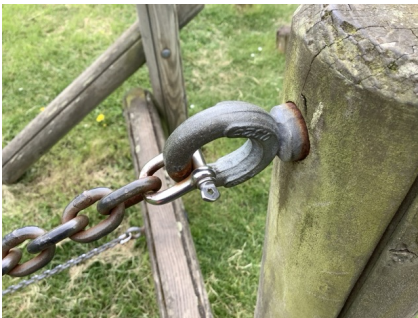
7
Butterfly shackles have been used, presenting non-rounded edges.	It is recommended that an alternative type of shackle that does not have sharp ends be used. Use fixings compliant with EN 1176.

It is recommended that an alternative type of shackle that does not have sharp ends be used. Use fixings compliant with EN 1176.

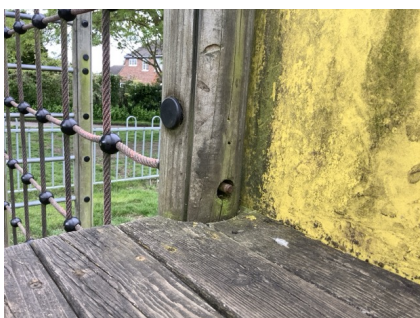
Cap missing.

Cap missing from top bar, allowing water ingress. Replace cap.
Cap missing exposing the bolt thread on the tower net connector. Tighten bolt and replace cap.

Replace., Read the notes for further action.

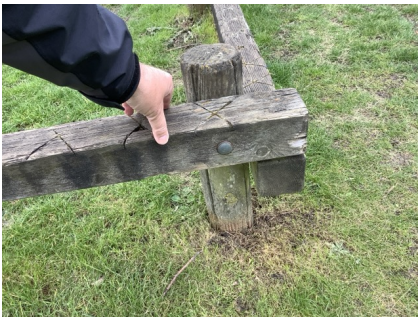
Bolt(s) loose.

Balance beam bolt loose. Secure.

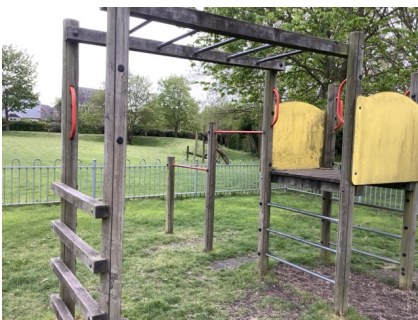
The protective surface under all bars and rings must be kept in good condition.

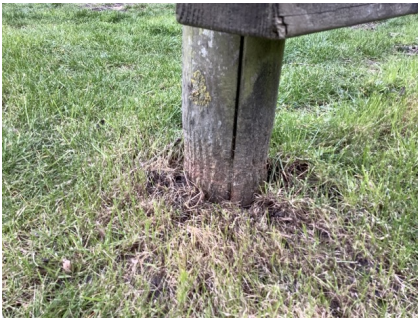
Strimmer damage is present on posts, allowing water to enter and timbers to soften. It can also remove the protective envelope around the timber. Prevent further damage and check timbers for decay throughout the year.

Prevent further damage.

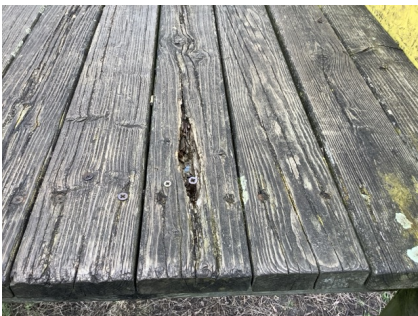
Timber is decayed.

Platform slat decaying and exposing screw.

Replace affected parts.

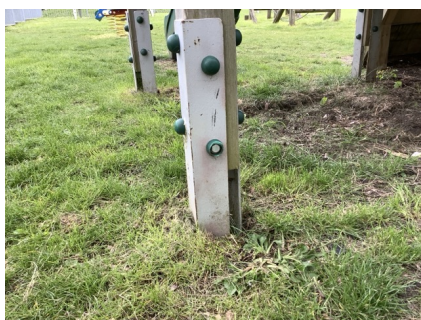
Cap missing.

Replace.

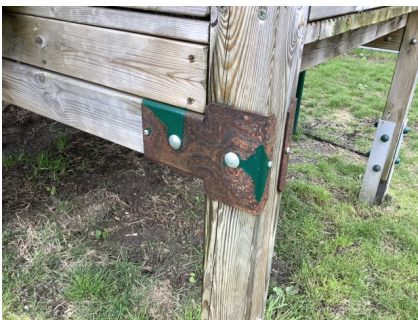
There is significant corrosion on this item.

All metalwork clamps rusting.

De-scale back to good metal and coat with lead free paint, using appropriate precautions. Repairs may be necessary where corrosion is severe.

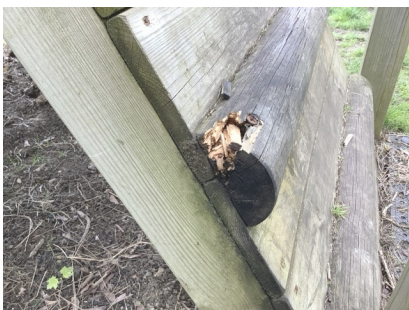
Timber is decayed.

Ramp half round log decaying.

Replace affected parts.

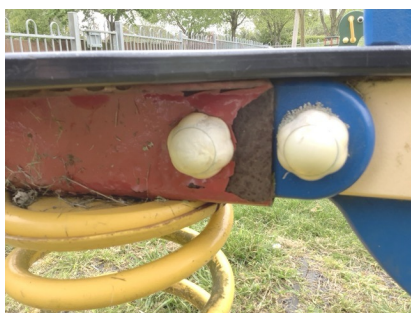
There is significant corrosion on this item.

De-scale back to good metal and coat with lead free paint, using appropriate precautions. Repairs may be necessary where corrosion is severe.

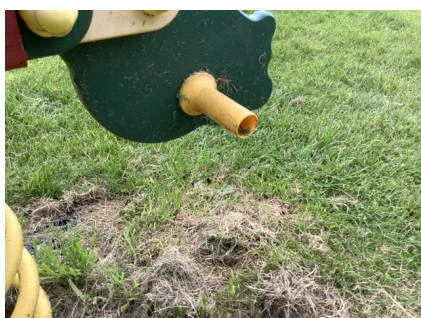
Cap missing.

Replace.

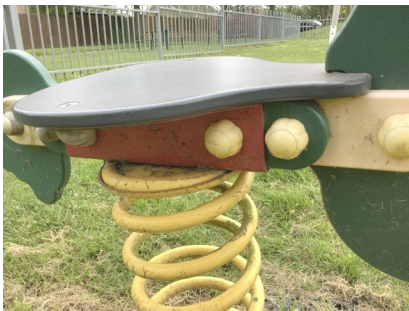
Fixtures loose or missing.

Body slightly loose in the frame.

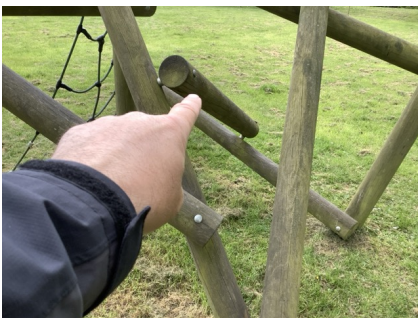
Bolt(s) loose.

Log fittings working loose. Secure.

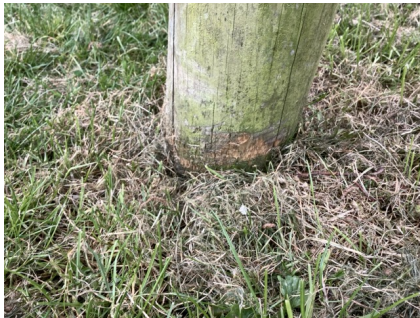
Strimmer damage is present on posts, allowing water to enter and timbers to soften. It can also remove the protective envelope around the timber. Prevent further damage and check timbers for decay throughout the year.

Prevent further damage.

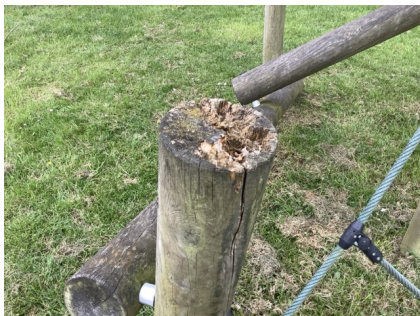
Timber is decayed.

Replace affected parts.
