Safety Inspection Report

Annual Inspection

Saxon Green

Great Paxton Parish Council

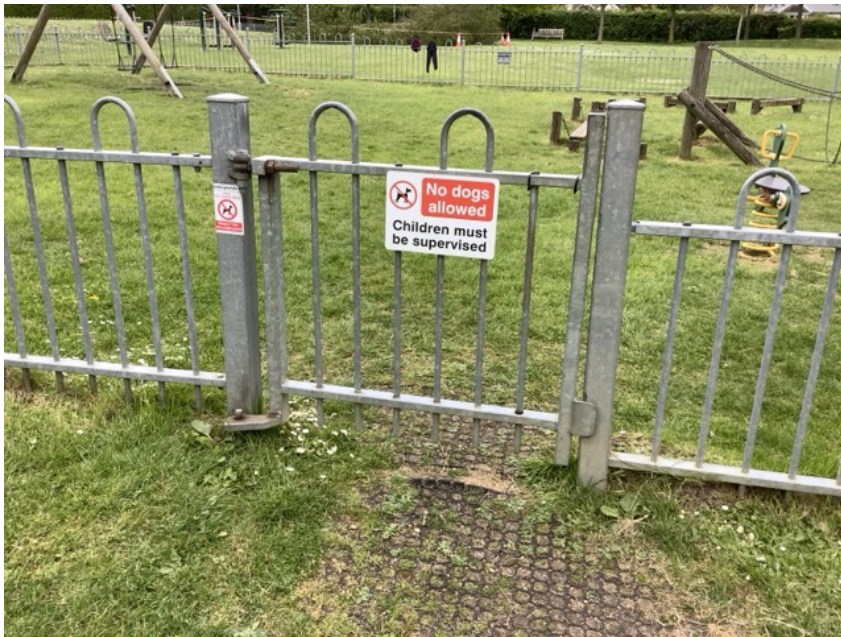
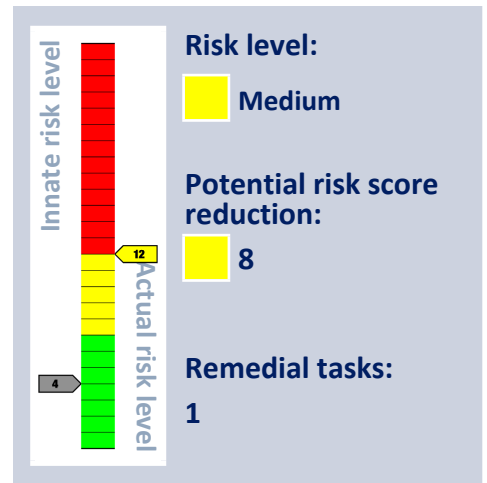
Gate

There is a crushing or shearing point on the side of the gate. Where the gaps reduce to less than 12 mm these have been known to cause serious, permanent injury to children, especially on the hinge side where the leverage forces are significant.

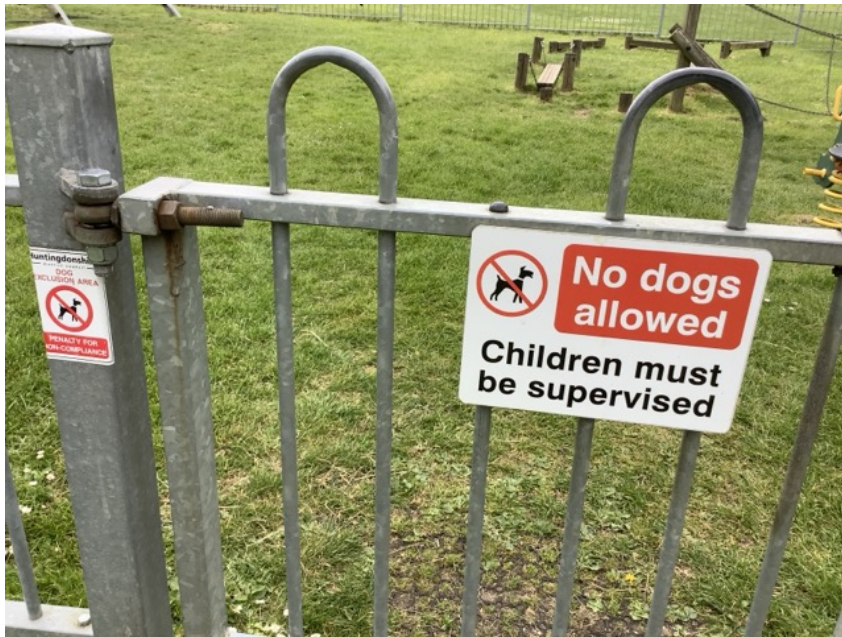
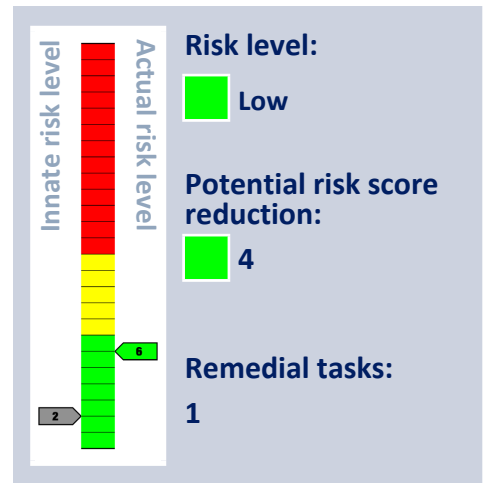
Signage - Playground

Dog ban & ownership signs recommended.

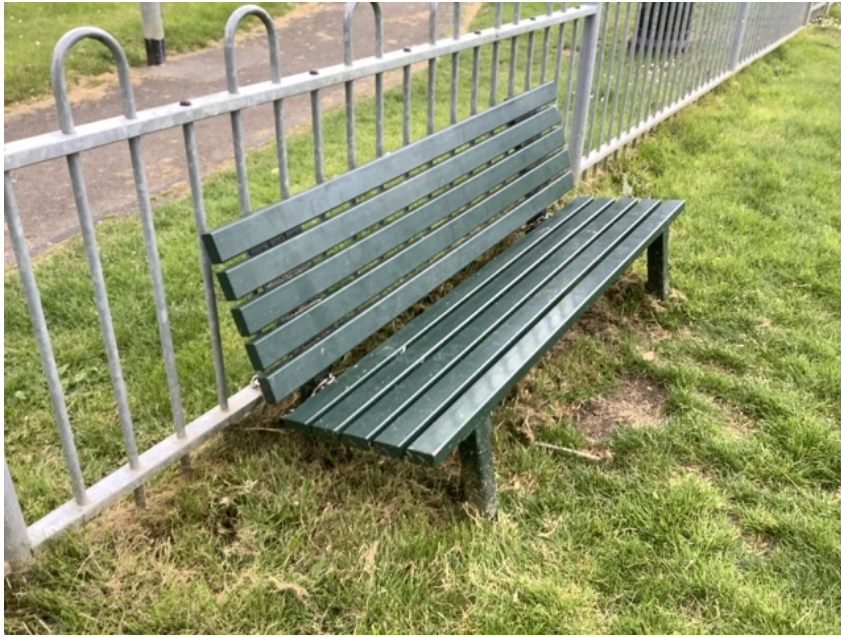
Seating

RoSPA recommend a minimum distance of 1 m between seat and fence. This is to reduce the likelihood of children vaulting the fence via the seat.

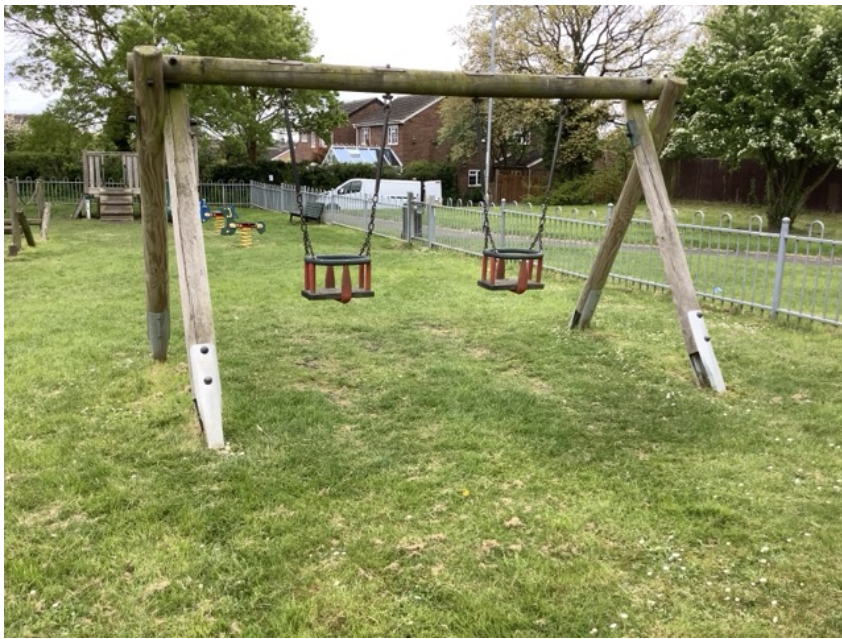
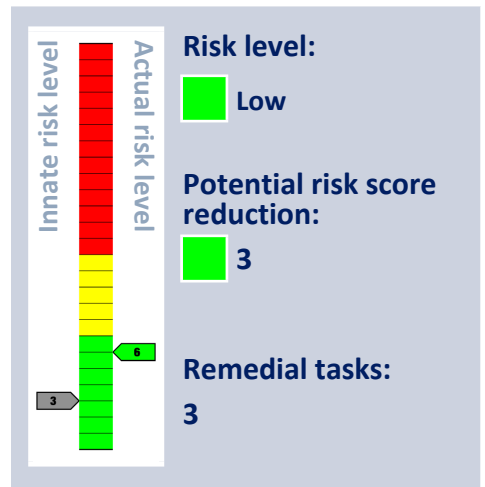
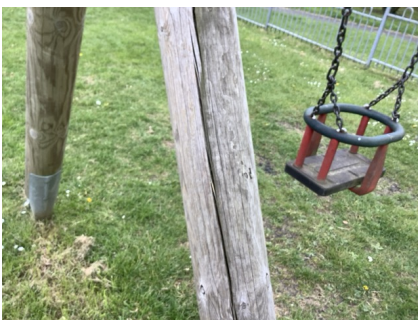
Swing - Toddler - 1 Bay 2 Seat (1850 mm)

Fixtures loose or missing.

Top bar swing hanger plate screws loose.

Paintwork is in poor condition.

De-scale back to good base material and coat with lead free paint, using appropriate precautions. Repairs may be necessary where corrosion is severe.

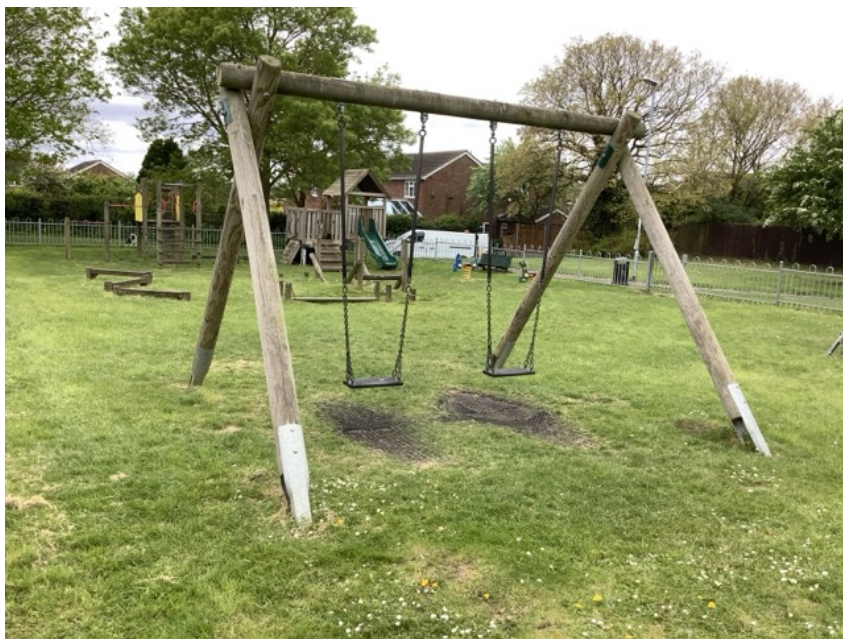
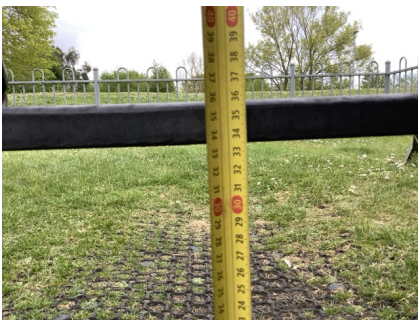
Swing - Junior - 1 Bay 2 Seat (2200 mm)

Surface needs repair.

Surface damaged. Replace.

Replace.

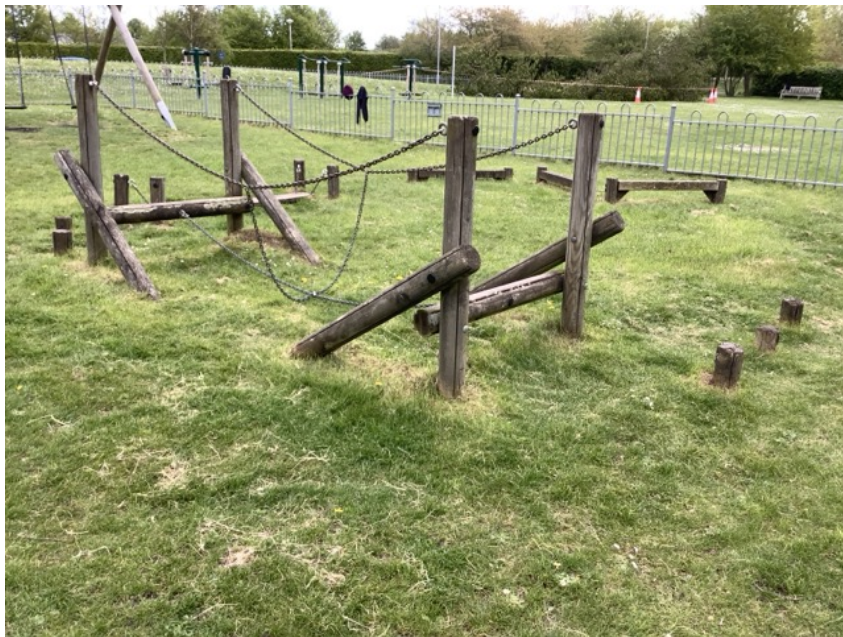
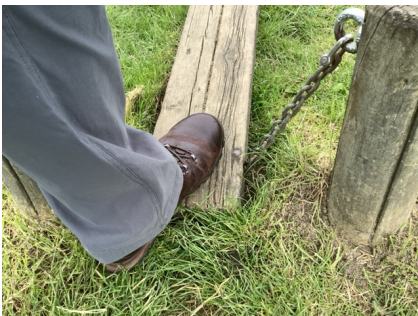
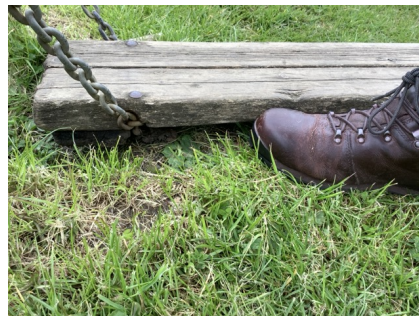
Burma Bridge - With Trail

Strimmer damage is present on posts, allowing water to enter and timbers to soften. It can also remove the protective envelope around the timber. Prevent further damage and check timbers for decay throughout the year.

Strimmer damage to the base of the uprights. This will allow water in and shorten the life span of the unit. Re-seal the damaged area and adjust the grass cutting program.

Timber is decayed.

Balance beam decaying.

Prevent further damage.

Replace affected parts.

It is recommended that an alternative type of shackle that does not have sharp ends be used. Use fixings compliant with EN 1176.

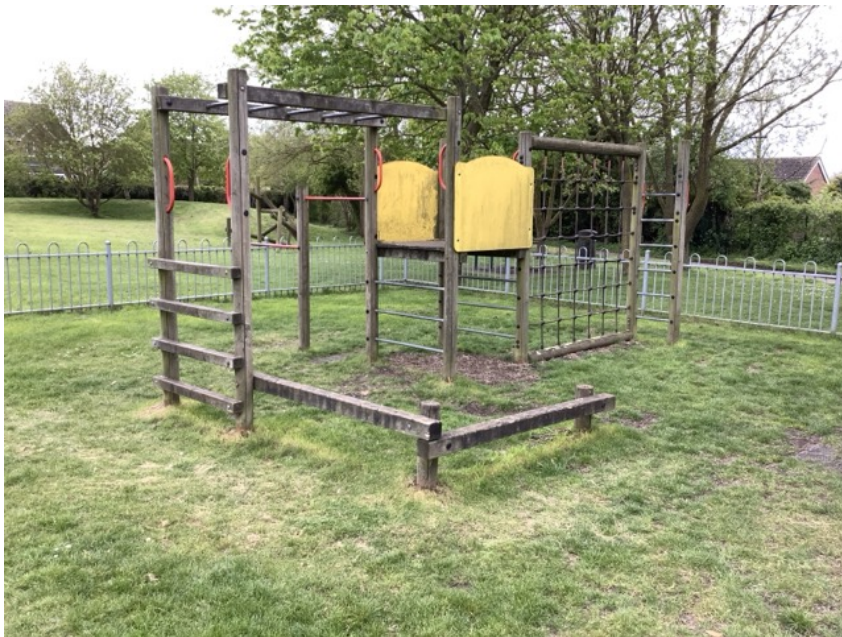
Climber - Frame & Net

Cap missing.

Cap missing from top bar, allowing water ingress. Replace cap.
Cap missing exposing the bolt thread on the tower net connector. Tighten bolt and replace cap.

Bolt(s) loose.

Balance beam bolt loose. Secure.

The protective surface under all bars and rings must be kept in good condition.

Timber is decayed.

Replace., Read the notes for further action.

Prevent further damage.

Replace affected parts.
